# **INDOOR AIR QUALITY ASSESSMENT**

**Division of Marine Fisheries  
Southeast Marine Fisheries Station  
50A Portside Drive  
Pocasset - Bourne, Massachusetts**

Prepared by:  
Massachusetts Department of Public Health  
Bureau of Environmental Health Assessment  
January, 2002

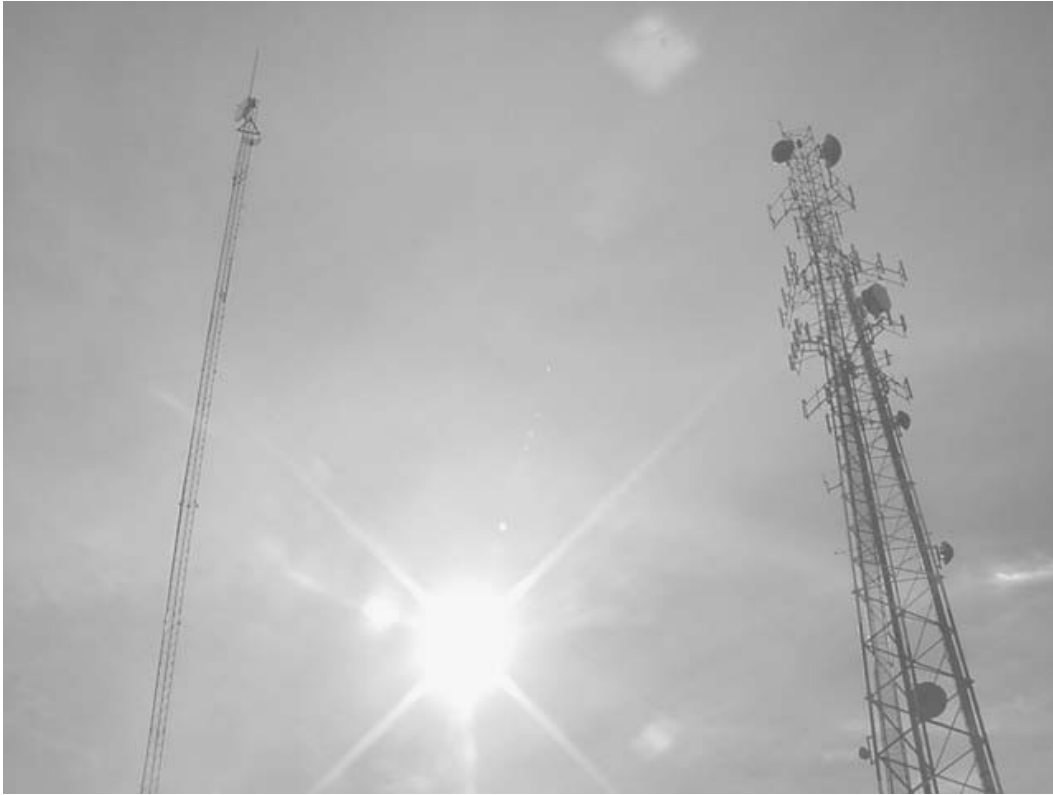
**Picture 1**

The assessment was prompted by complaints of chronic ringing of the ears (tinnitus) as well as dizziness, nausea, difficulty sleeping and other symptoms over the last 1-2 years among four DMF staff members. The DMF staff are concerned over the possible role of IAQ producing these symptoms. Employees also believe their symptoms may be attributed to radio towers adjacent to this office building (see Picture 1). The building was visited by the MDPH Radiation Control (RC) program on May 16, 2001 to examine electro magnetic radiation levels and a possible relationship between the radio towers and reported symptoms. At the time of the BEHA assessment the RC report was pending.

**Radio Towers Adjacent to 50A Portside Drive**

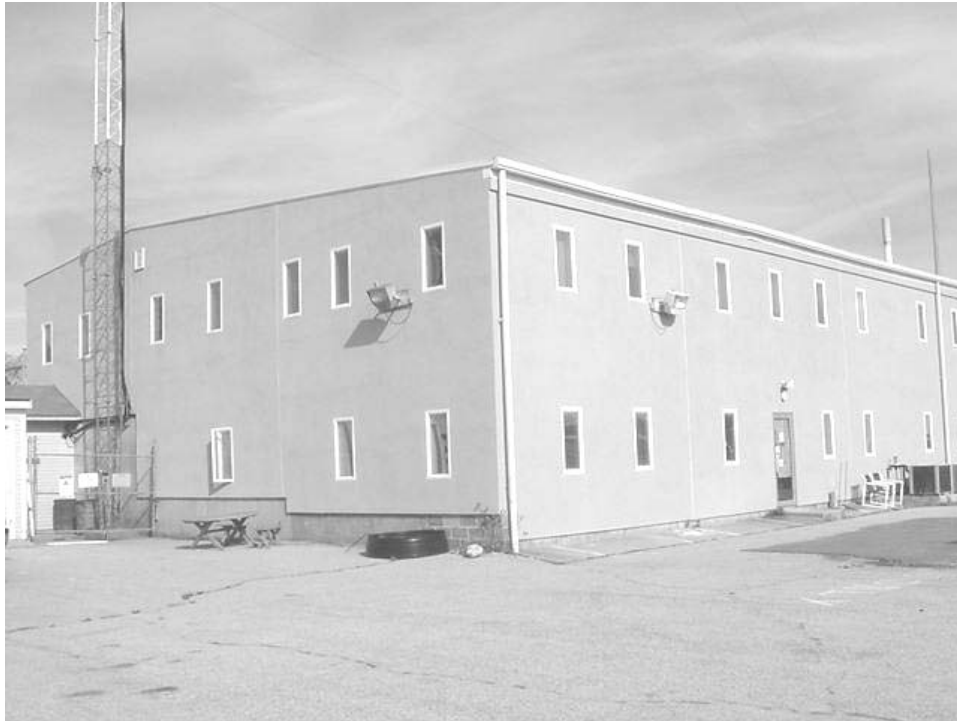
**Picture 2**

**Rear View of DMF Facilities: Note Radio Tower along Southwest Wall of Building Where Employees Complaining of Symptoms Work (First Floor Windows)**

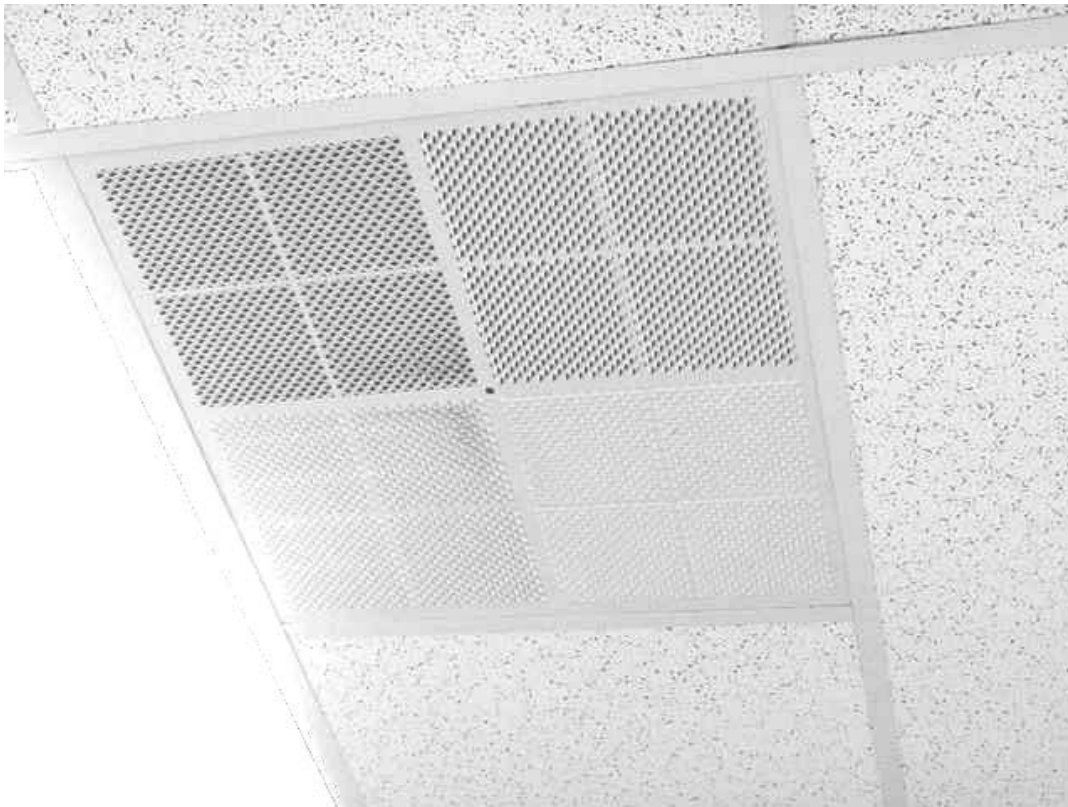
**Picture 3**

Ventilation is provided through ducted, ceiling vents (see Picture 3). Air is returned to the AHUs by wall and/or ceiling-mounted grilles through ductwork. A number of exhaust vents were obstructed by boxes, file cabinets and other items (see Picture 4) inhibiting airflow. Further limiting airflow were several louvers for return vents that were completely shut (see Picture 5).

**Ceiling-Mounted Supply Vent**

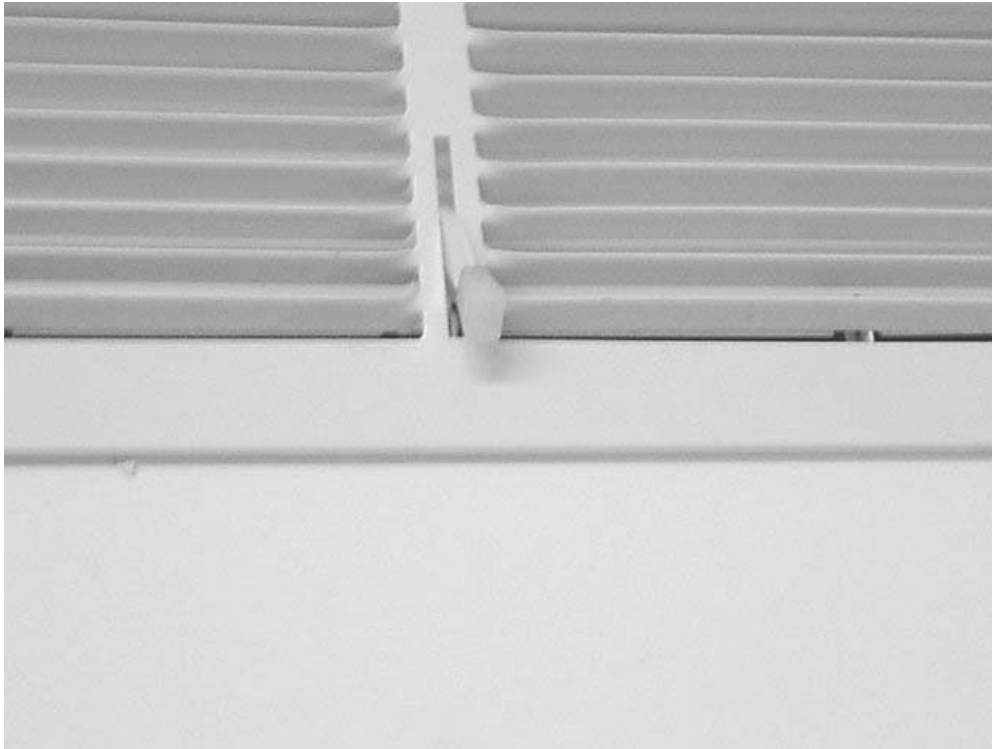
**Picture 5**

**Adjustment Switch for Return Vent, Note Vent was Completely Shut Preventing Airflow**

5. Remove all blockages from return vents and ensure return vent louvers are open to facilitate airflow.
6. Consider having the ventilation system balanced by an HVAC engineering firm.

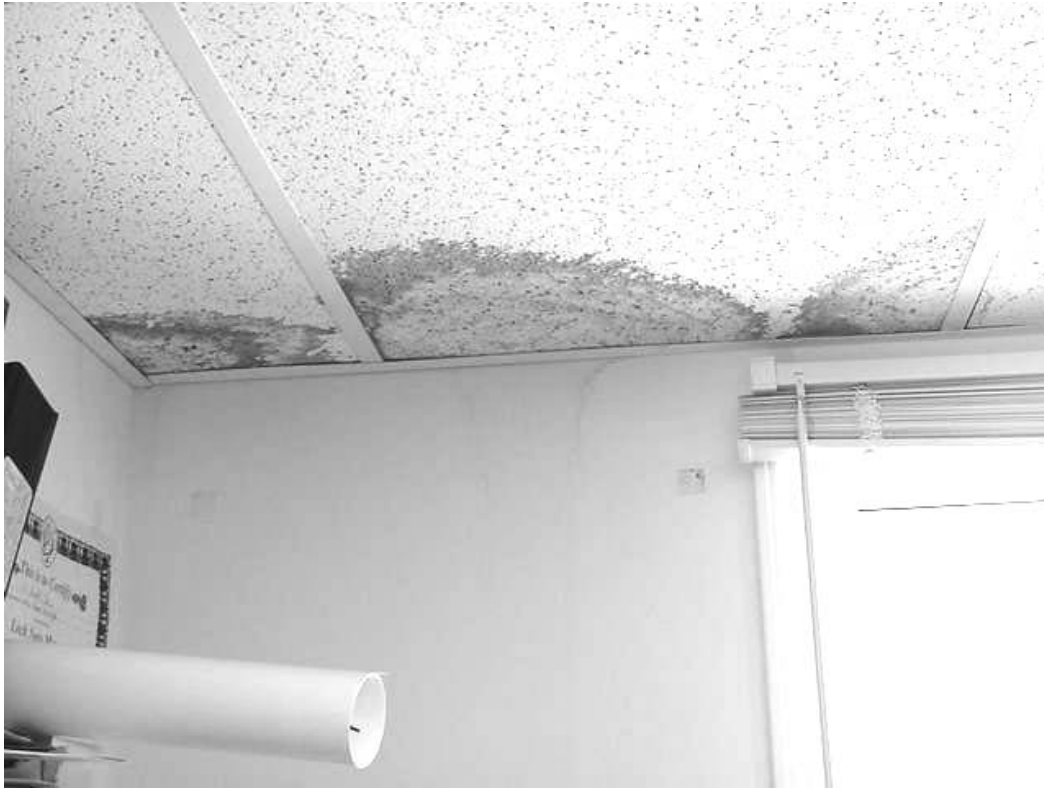
**Picture 6**

Several areas had water stained ceiling tiles, which is evidence of historic and/or current roof or plumbing leaks. An active roof leak was reported in the corner of the conservation /engineering office (see Picture 6). Office staff had reportedly contacted the landlord, who visited the building shortly after the discovery of the leak to examine roofing/flashing conditions and to identify the source of water penetration. Building staff could not verify if repairs had been made to correct the problem. Ceiling tiles can provide a source of microbial growth and should be replaced after a water leak is discovered and repaired. Water staining was also noted along the floor/lower wall of the handicapped ramp (see Picture 7).

**Water Damaged Ceiling Tile from Recent Leak in Engineering/Conservation Office**

12. Continue to work with landlord to report, identify and repair leaks. Replace water damaged ceiling tiles. This measure will remove actively growing mold colonies that may be present. Ceiling tiles should be removed at a time when employees are not present in the workplace. Contain the area where ceiling tiles are removed to prevent the

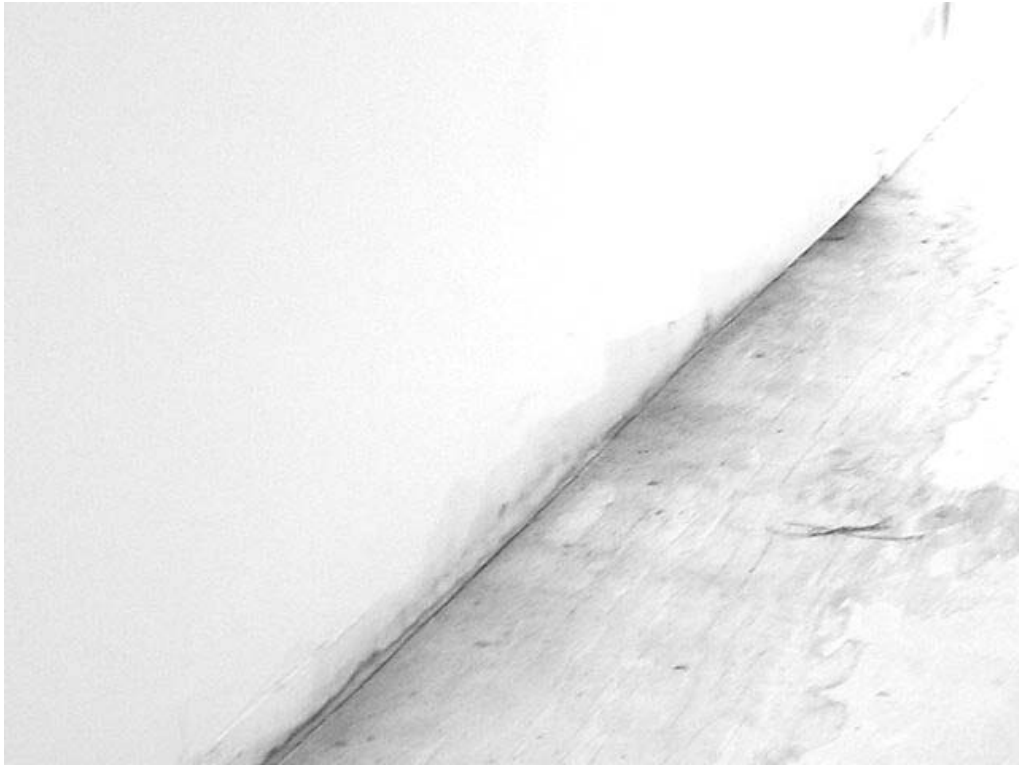
**Picture 7**

**Water Staining along Wall/Floor Junction along Handicapped Access Ramp**

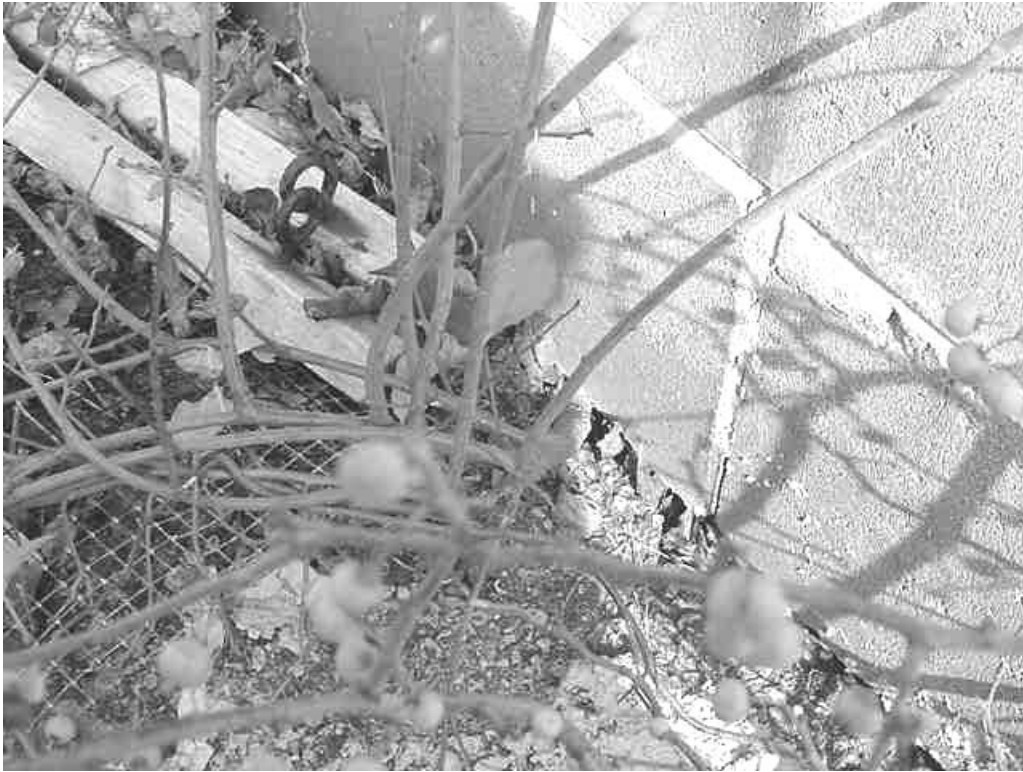
**Picture 8**

Water infiltration and moistening of carpeting was reported in the corner of Mr. Germano's cubicle on the ground floor. BEHA staff inspected conditions along the outside perimeter of the building to identify breaches in the building envelope that may be a source of water penetration. Small trees/stumps and other plants were growing in the tarmac/exterior wall junction (see Picture 8). The growth of roots against the exterior walls, as well as spaces between the tarmac and exterior walls of the building, can bring moisture in contact with the foundation. The freezing and thawing action of water during winter months can create cracks and fissures in the foundation. Over time, this process can undermine the integrity of the building envelope and provide a means of water entry into the building through capillary action through foundation concrete and masonry (Lstiburek, J. & Brennan, T., 2001). Repeated water damage to porous building materials (e.g., wallboard, ceiling tiles, carpeting) can result in microbial growth. The

**Trees/Plants Growing between Tarmac and Foundation**

11. Remove plant growths against the exterior wall/foundation of the building to prevent water penetration. Examine foundation/exterior wall for breaches that can allow for water penetration and repair/seal.

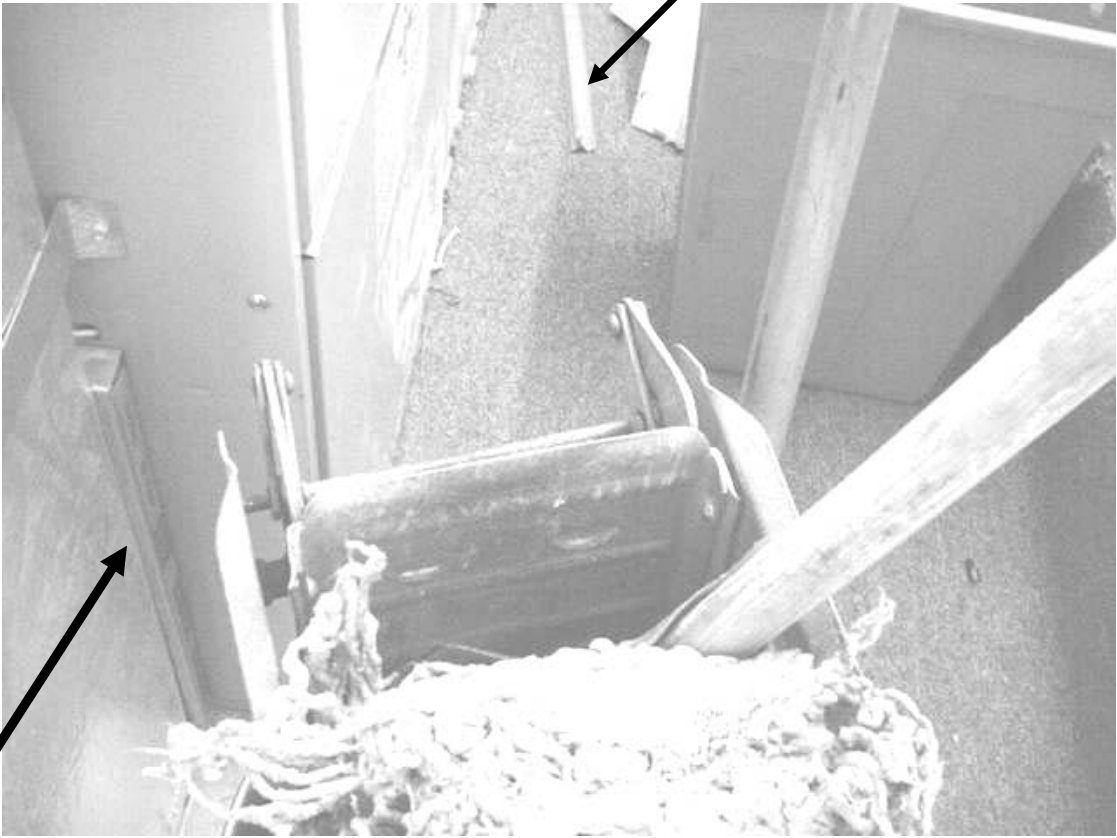
**Picture 9**

Several other conditions that can potentially affect indoor air quality were identified. DMF staff could not confirm if the building has an HVAC preventative maintenance plan in place. BEHA staff examined the condition of filters inside the AHUs. Filters were clean and appeared to have been recently changed. However, the filter access panel in the ground floor mechanical room was not re-installed and was located several feet from the unit on the floor (see Picture 9). Also noted in the mechanical room were a used mop and a bucket in close proximity to the AHU. Mops and buckets can be sources of wet/musty odors. The breach in the AHU casing created by the lack of the filter access panel may draw air from the surrounding space into the unit. As air bypasses filters, the opportunity exists for airborne dirt, dust, odors and particulates to be distributed to occupied areas via the HVAC system. In addition, these materials can accumulate on flat surfaces (e.g., desktops, shelving, and carpets) in occupied areas and subsequently be re-aerosolized causing further irritation.

**Ground Floor Mechanical Room**

1. To maximize air exchange, the BEHA recommends that both supply and exhaust ventilation operate continuously during periods of building occupancy independent of thermostat control. Operate building thermostats in the fan “on” position to provide constant airflow.
2. A preventative maintenance program for all HVAC equipment should be developed and implemented, which should include changing filters for AHU equipment as per the manufacturer’s instructions or more frequently if needed, as well as the examination of all HVAC equipment periodically for maintenance and function.
3. After replacing filters, affix filter access.
4. Do not use mechanical rooms for storage (e.g., mops and buckets).

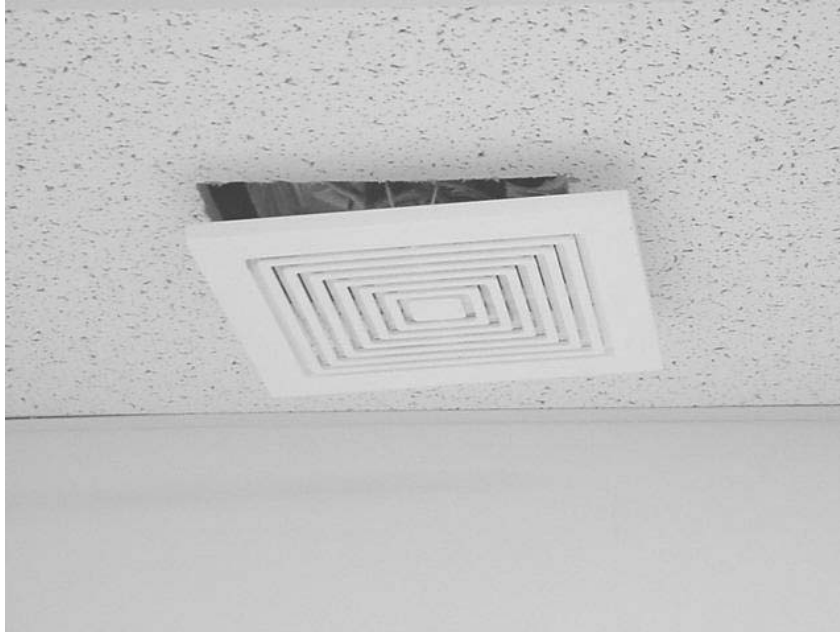
**Picture 10**

Restrooms are equipped with wall-switch activated exhaust vents. These vents were operating during the assessment, however it appears that they are not ducted out of the building. BEHA staff examined conditions above ceiling tiles and found that restroom vents exhaust odors and moisture into the ceiling plenum. When occupants exit the restroom and deactivate the wall-switch, it can allow for odors and excess moisture to reenter through spaces around ceiling tiles and/or the inactive vents themselves. The exhaust vent in the ground floor restroom was observed hanging (see Picture 10). Furthermore, restroom doors are not undercut and do not have passive door vents to allow for transfer air movement into the restrooms.

**Hanging Restroom Exhaust Vent on Ground Floor**

7. Repair damaged exhaust vent in the ground floor restroom shown in Picture 10.
8. Consider placing restroom vents on a timer instead of a wall switch to provide constant exhaust during work hours.

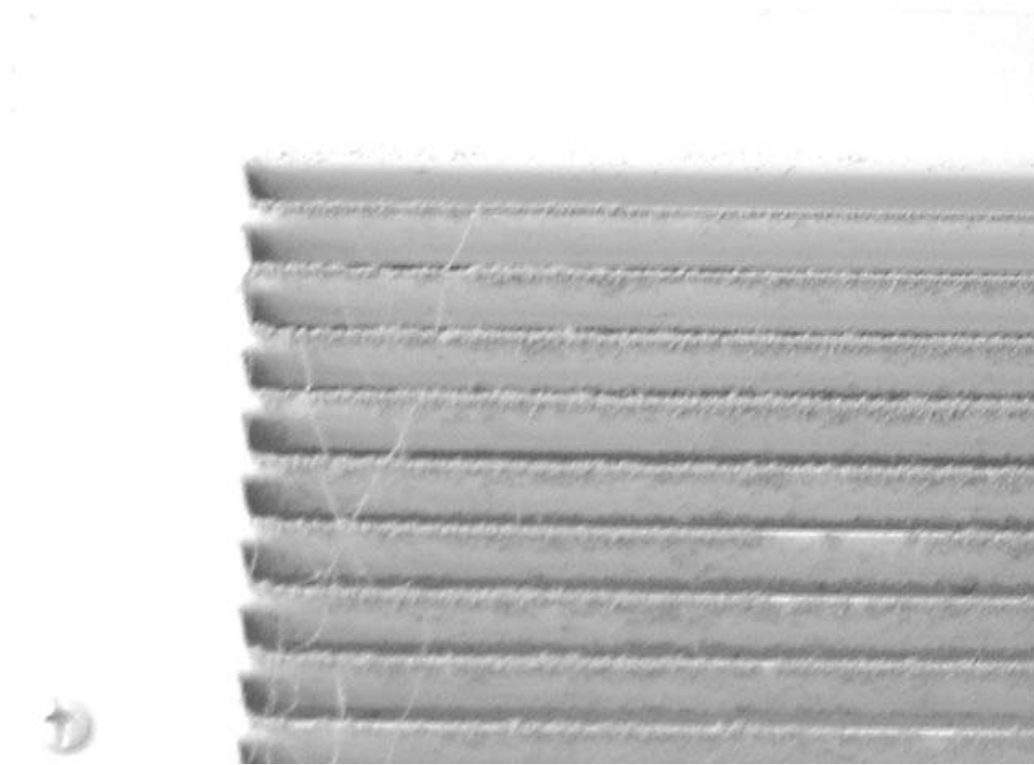
**Picture 11**

**Return Vent Covered with Dirt, Dust and Cobwebs**

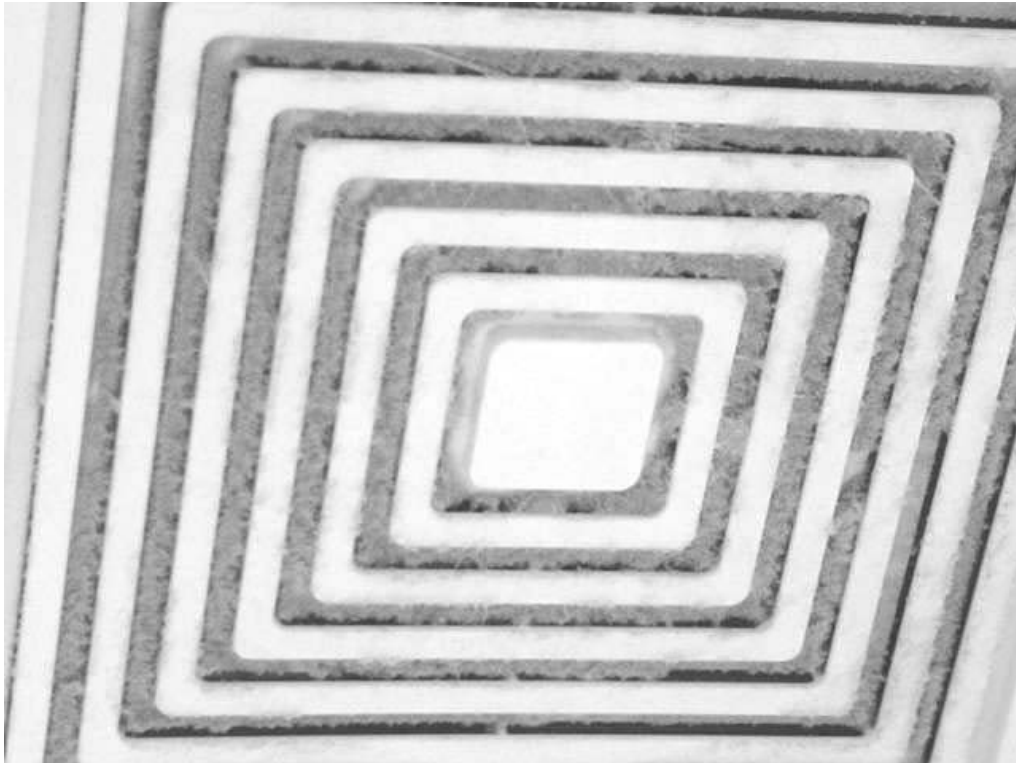
**Picture 12**

**Restroom Exhaust Vent Occluded with Dust**
